Saving San Sebastian Basilica

FROM POINTS TO THE UNDERSTANDING OF THE BUILDING

BY LOURDES G. CEREZUELA, DIGISCRIPT PHILIPPINES INC.

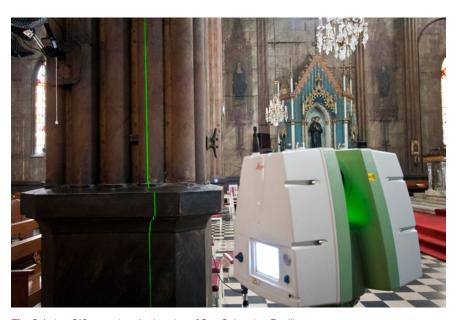
Fig. 2: Leica C10 scanning the interior of San Sebastian Basilica.

Each scan location was methodically placed to make sure that inaccessible areas of the church were also captured. With strict control measures and the industry best practices workflow, DigiScript was able to complete the scanning and survey of the entire Basilica in 4 days with a total of 85 scans that were registered together to create one complete 3D point cloud model that is now the basis for all the further studies by the other professional consultants. The 3D point cloud serves as a guide for the team to identify numerous deficiencies in the building that would have otherwise not been visible without it (see Fig. 2).

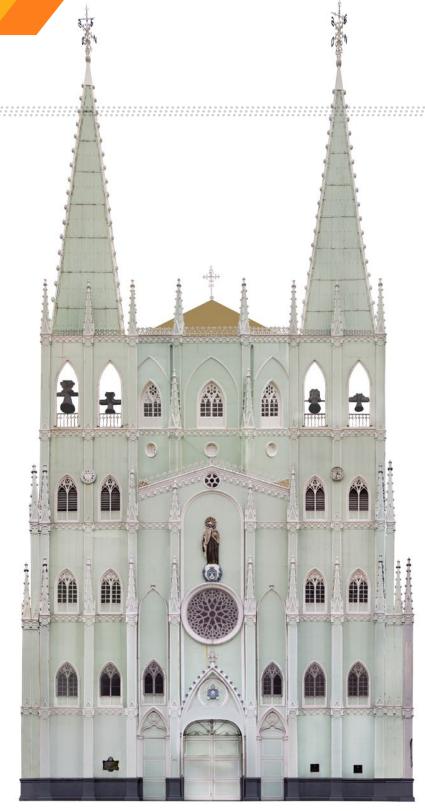
Fig. 3: External photoplan of the main access to the church.

In Europe there is a well-known and widely used method to create photoplans for preservation projects. However, in countries like the Philippines, among many others including the United States, this technique is still not put into practice, either due to unfamiliarity or lack of training. Photoplans are primarily for the building's internal and external facades. To create them it is necessary to superimpose the orthoimages from the point cloud data with the CAD drawings and the photograph parts like a puzzle.

All the pictures have been taken with a reflex camera and each shot provides an adequate overlap area with the contiguous one and were taken maintaining the angle of incidence as perpendicular as possible to the surface in order to minimize distortions of perspective. All the areas where it was not possible to take pictures and/or

occupied by non-significant elements have been integrated with a neutral color. Estan Cabigas was the photographer who took the high quality pictures to help with this method. In order to create the photoplans, the orthoimages are extracted from Cyclone software in .tiff files with the same orientation as the facades. Simultaneously, CAD drawings are created also from

the point cloud data with the plug-in Cloudworx in AutoCAD. Then each photograph was rectified using one of many computer software programs currently on the market, such as Photoshop, manipulating them to move the pixels to the accurate position.

Photoplans derived from high quality digital photographs will provide a record of color, materials, texture, degradation and the current state of conservation of a building or structure, a valuable tool when planning for restoration or providing a detailed record of a landmark. Fortunately, the cameras integrated

into the scanners are improving and it will not be long until this meticulous, drawn-out and manual process will be done automatically and with high accuracy (see Fig. 3).

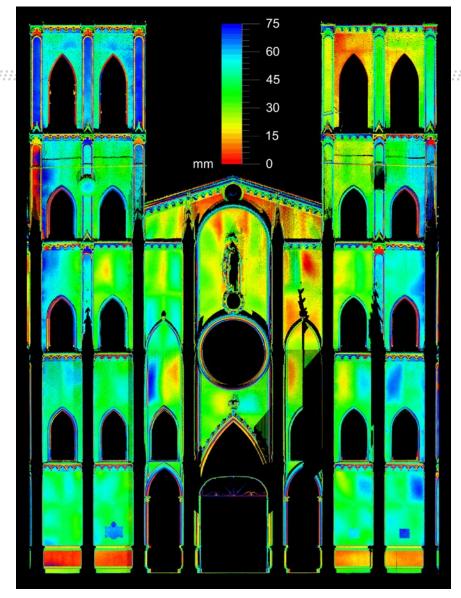
Fig. 4: Forensic mapping study of an internal façade surface.

The main part of the project consists of the surface mapping. By leveraging information obtained from the dense 3D surface data of a laser scan, topographic maps can be created of linear surfaces. These forensic studies clearly illustrate deviations from horizontal and vertical planes. With this information we can quickly identify problem areas and the extent of surface movement that the wind loads or settlement have caused to the surfaces of the church. It is particularly important to this project because movement of component parts of the building has resulted in the deformation of wall, columns and ceiling panels. This method can reveal causal mechanisms for this condition and help the structural engineers to confirm if their suspicions about the warping of wall panels are due primarily to seismic tremors (see Fig. 4).

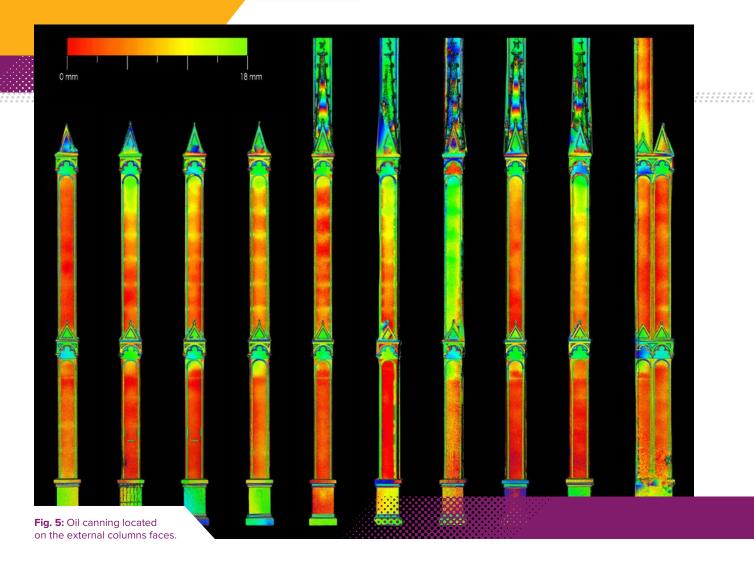
The last method of analysis consists of slicing the external and internal walls, floors, ceilings and external columns. Unfortunately, this method cannot be applied to nonlinear surfaces, such as curved, spherical or parabolic. The topographic maps are colored and each color is a slice of 3mm of thickness. The number of colors chosen has varied depending on the size of the area to study. For columns and small areas 16 colors have been chosen, whereas for the big areas it can be up to 32 colors. In the columns we found the presence of "oil canning", a waviness in flat metal areas of roofing and siding panels that usually originates from the steel mill. It is an

aesthetic problem and normally structural integrity is not affected. However, structural integrity must be reviewed if the distortion results from an extreme external influence. Waviness has been located in the second level of the front faces of 10 columns and also in the lateral faces of 2 columns (see Fig. 5).
